Hydrogen Attack of U-Bend Pipe Joint Connecting Heat Exchangers at a Methanol Plant

Abdel-Monem El-Batahgy, Sayed Hussein

Index Terms— Microstructure degradation, Hydrogen attack, Catastrophic failure, Material selection, Periodic inspection

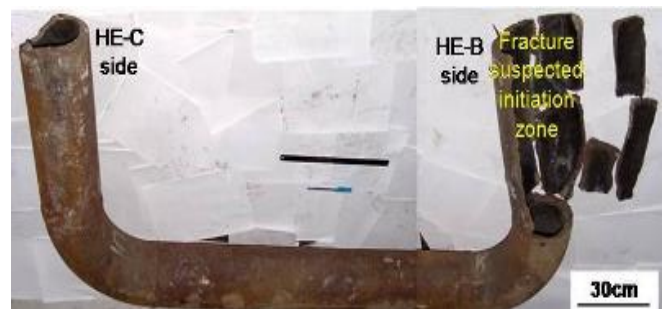
On site investigation showed that the U-bend pipe joint was fractured and separated from the shell nozzles of both heat exchangers B and C. General view of the fractured U-bend pipe joint after reassembling its segments is shown in Fig. 1. Visual inspection showed that the fracture was occurred at the two ends of the U-bend pipe joint connected to the heat exchangers B and C. However, existence of several segments of the fractured pipe joint on the heat exchanger B side increases the possibility of starting the fracture on this side. Another important point is the absence of bulging of the failed pipe joint.

Fig. 1. General view of the fractured U-bend pipe joint connecting the heat exchanger B (HE-B) to the heat exchanger C (HE-C).

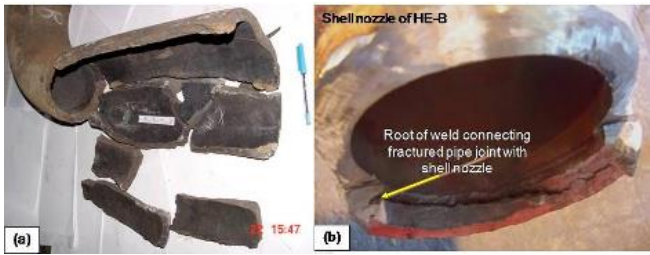
Enlarged view of the fracture zone on the heat exchanger B side showed thick wall rupture where no indications for corrosion damage or other excessive wastage were observed (Fig. 2-a). Results of wall thickness measurements showed no remarkable reduction in wall thickness of both fractured and non-fractured zones of the failed U-bend pipe joint where wall thickness of 18.7–19.1 mm was obtained compared with 19 mm nominal wall thickness, that in turn indicates brittle fracture. Close up view of the fracture surface of the shell nozzle of the heat exchanger B showed crack propagated from the circumferential weld root toward the outer surface (Fig. 2-b). In other words, beveling the fracture surface increases the possibility that the fracture was initiated at the inner surface of the circumferential weld connecting the U-bend pipe joint to the shell nozzle. Dye penetrant test results showed no indications for surface cracks either around or away from the fracture zones

Fig. 2-(a). Enlarged view of the fracture zone on the heat exchanger B side showing thick wall rupture and (b) close up view of the fracture surface of the shell nozzle of the heat exchanger B showing crack propagated from the circumferential weld root toward the outer surface.

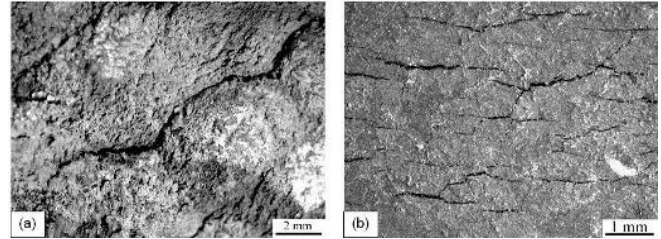
Low magnification stereoscopic photograph of the fracture surface on the side of the U-bend pipe joint is shown in Fig. 3-a. It can be seen that the fracture surface showed a brittle appearance with cracks propagated through grain boundaries. Low magnification stereoscopic photograph of the inner surface of the U-bend pipe joint is shown in Fig. 3-b. The important notice is the existence of large amount of surface cracks at the inner surface of the fractured pipe joint. On the other hand, no surface cracks were observed on the outer surface of the failed pipe joint. Scanning electron microscopic examinations of the fracture surface confirmed the brittle fracture mode and disclosed complete decomposition of pearlite into ferrite and spheroidal carbides. Another important finding is the existence of voids in pearlite colonies where fissures and cracks were propagated through such voids (Fig. 4).

Fig. 3. Low magnification stereoscopic photographs of the fracture surface (a) and the inner surface (b) of the failed U-bend pipe joint.

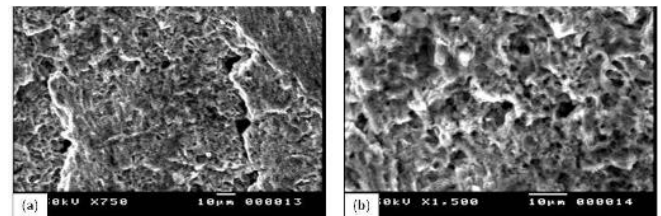
Fig. 4. Scanning electron microscopic photographs of the fracture surface showing brittle fracture mode where fissures were propagated through voids formed in pearlite colonies.

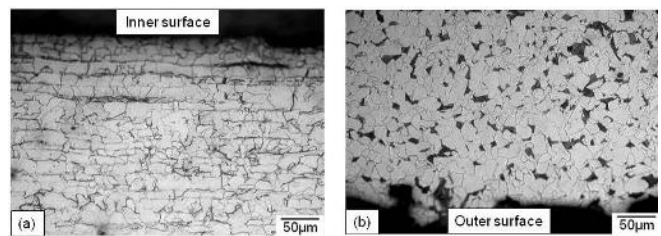
Optical microscopic photographs of a cross section taken from fracture suspected initiation zone are shown in Fig. 5. The most important notice is the occurrence of decarburization and the existence of voids and fissures at the pipe' inner surface (Fig. 5-a) while normal ferrite-pearlite structure is still existed at the pipe' outer surface (Fig. 5-b). Optical microscopic photographs of a cross section taken from a non-fractured zone, i.e. straight portion of tube, are shown in Fig. 6. It is clear that a microstructure degradation similar to that of the fractured zone (Fig. 5) was observed. In other words, decarburization was occurred and voids as well as fissures were formed at the pipe' inner surface (Fig. 6-a) while normal ferrite-pearlite structure was observed on the outer surface (Fig. 6-b). The microstructure degradation has been confirmed using scanning electron microscopy where decarburization, voids and fissures were clearly observed on the pipe' inner surface (Fig. 7-a, b) while pearlite still has its lamellar morphology on the outer surface (Fig. 7-c, d). The linear fissures observed on the inner surface are along the pipe axis.

Fig. 5. Optical microscopic photographs of a cross section taken from fracture suspected initiation zone showing decarburization and fissures on the inner surface (a) and normal ferrite-pearlite structure on the outer surface (b).

Based on the results obtained in this investigation, it can be concluded that failure mechanism of the subject U-bend pipe joint is attributed mainly to hydrogen attack associated with decarburization. The cause of this failure type is related to an improper selection of the material for the subject working conditions. Steel suffers from high temperature hydrogen attack when the hydrogen from the flow stream (hydrocarbons) seeps into steel at high temperatures. Hydrogen reacts with the carbides in the steel, decarburizing the steel and forming methane gas or bubbles at the grain boundaries with no loss of thickness. The methane gas bubbles grow with time and result in voids and micro-cracking and lower the toughness of the steel. In other words, combination of decarburization and micro-cracking reduces the fracture toughness of steels and lead to major failures with no thickness reduction or corrosion associated with it.

Hydrogen attack of steel can be avoided by following the operating limits on temperature, partial pressure of hydrogen, and alloy composition set forth by the API Standard 941 [10]. Therefore, the used low carbon steel ASTM A105 was replaced with a higher grade type; ASTM A335P11 (1Cr-0.5Mo) steel for a longer lifetime of the subject equipment. It is recommended that the heat exchangers and its connecting U-bend pipe joints to be periodically subjected to non-destructive inspection to evaluate its condition to be able to make the right decision for its replacement in order to avoid sudden failure and unexpected shutdown. This includes dye penetrant test, magnetic particle test, ultrasonic test, SUMP or microstructure examination using replica technique, and hardness measurements.

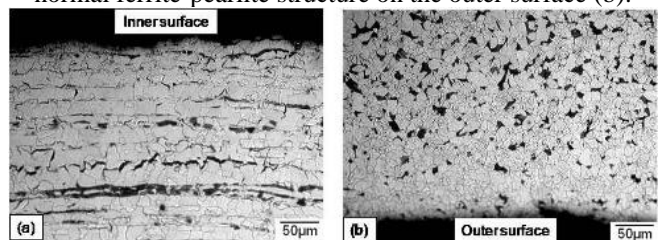
Fig. 6. Optical microscopic photographs of a cross section taken from non-fractured zone showing decarburization and fissures on the inner surface (a) and normal ferrite-pearlite structure on the outer surface (b).

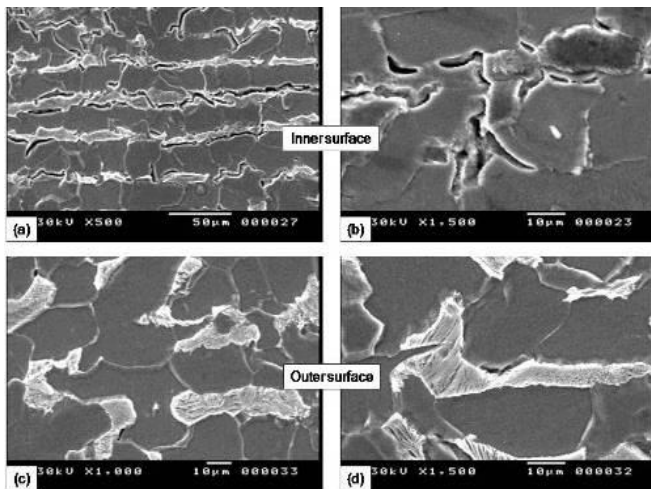
Fig. 7. Scanning electron microscopic photographs of a cross section taken from fracture suspected initiation zone. Note decarburization, voids and fissures on the pipe inner surface (a, b) while pearlite lamellar morphology still existed on the outer surface (c, d).
