Role of Welding Defects on the Failure of Sub-sea Carbon Steel Gas Pipeline

H. Abdel-Aleem, S. A. Khodir

Abstract— Sub-sea gas pipeline spool made of a carbon steel alloy API 5XL grade X52 was failed at a girth weld adjacent to 45° elbow after 5 years of operation. The nominal diameter of the failed spool is 4". The failed spool was received for failure analysis and data collections. Examination of the interior surface of the spool revealed moderate general corrosion with few shallow pits except the area near the girth of the circumferential welds showed severe localized pits where the corrosion attack occurred at the fusion line between weld metal and heat affected zone. Based on the macroscopic, SEM and XRD analyses, the failure was occurred due to flow enhanced accelerated localized corrosion attack related to improper welding techniques of girth welds. Undercut and / or excess bead penetration at the weld root and high heat input could be the primary causes for the localized turbulent flow conditions created around the girth welds which in turn led to this accelerated corrosion failure assisted by thermally stressed heated affect zone of the base metal. The presence of corros

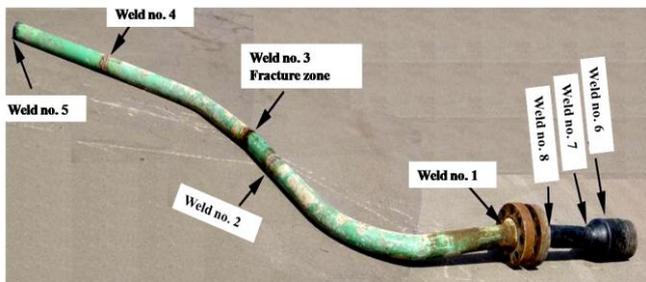
ending the twenty years of estimated remaining life assessment. The spool has 8 circumferential welds and leak occurred at a 4" nominal diameter girth weld (no. 3) adjacent to a 45 degree elbow as shown in Fig. 1. The Spool including fracture zone was subjected to detailed failure analysis.

Fig. 1 Photograph of the received spool.

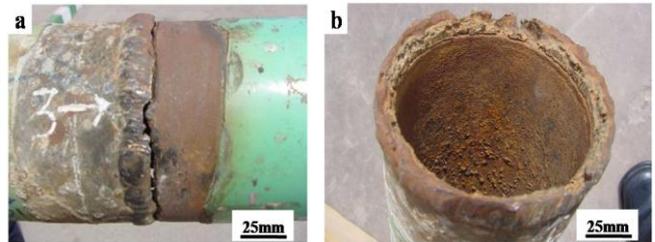
Fig. 2 Close-up view of the failed region adjacent to weld no. 3.

strength of pipe which in turn leading to failure as shown in Figs. 2-4.

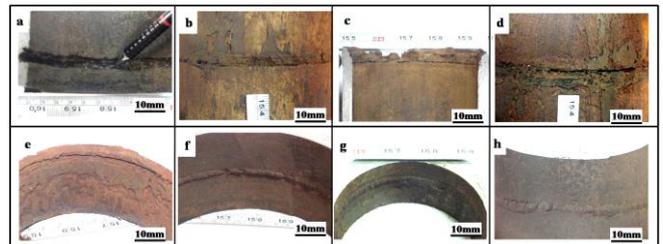
Chemical analysis of the base metal and weld metals is shown in Table 1. The results showed the conformity of the tube material to the required specifications; API 5XL grade X52. The visual inspections after removing the external coat showed neither corrosion products nor mechanical damage along the received part. General and close-up views from the circumferential weld no. 3 of the fractured spool are shown in Figure 2. It can be noticed that fracture had occurred along the fusion line of the weld. Close-up views of the inner surfaces at the circumferential welds are shown in Fig. 3. The inner surface of the pipe showed moderate general corrosion and few shallow pits compared to the weld zone, which was seriously damaged. The circumferential welds numbered 1, 2, 4 and 5 have shown relative damage with deep grooves and rounded holes. The worst degradation of damage is observed at circumferential weld no. 1 while the least ones was no. 2. Girth Welds no. 6 & 7 around the reducer and the flange weld no.8 showed grooves at fusion lines and excess penetration at the weld root beads.

Fig. 3 Close-up views of inner surfaces containing welding zones : (a) weld no1, (b) no. 2, (c) no.3, (d) no. 4, (e) no. 5, (f) no.6, (g) no.7 and (h) no. 8.

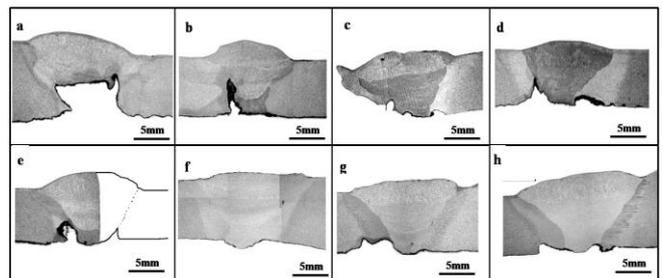
Macrostructures of the cross sections normal to the welding direction are shown in Fig. 4. Severe and deep attacks along fusion lines between weld metals and heat

affected zones rather than base metal are clearly observed in circumferential welds no. 2, 3, 4 and 5. Optical microstructures of base metal and weld metal of joint no. 3, revealed by Nital etchant solution are shown in Fig. 5. The microstructure of base metal (BM) is elongated ferrite - pearlite structure (Fig. 5a) which is typical for API 5L grade 52. The microstructure for weld metal (WM) consists of acicular ferrite, side plate ferrite and grain boundary ferrite (Fig. 5b). The structure of the heat affected zone (HAZ) consists of pearlite and upper bainite as shown in Fig. 5c. The HAZ grains are coarse near the fusion line and become finer as go far from fusion line (Fig. 5d). Detailed examination of the weld zone of weld no.3 showed defects (porosity) at both root bead and final bead of the weldment. The corroded area of the fusion line showed some remaining corrosion products as shown in Fig. 6. The tip of the remaining part of weld no. 3 after corrosion showed fine grooves and gullies.

Fig. 4 Macrostructures at cross-sections of all girth welds : (a) weld no1, (b) no. 2, (c) no.3, (d) no. 4, (e) no. 5, (f) no.6, (g) no.7 and (h) no. 8.

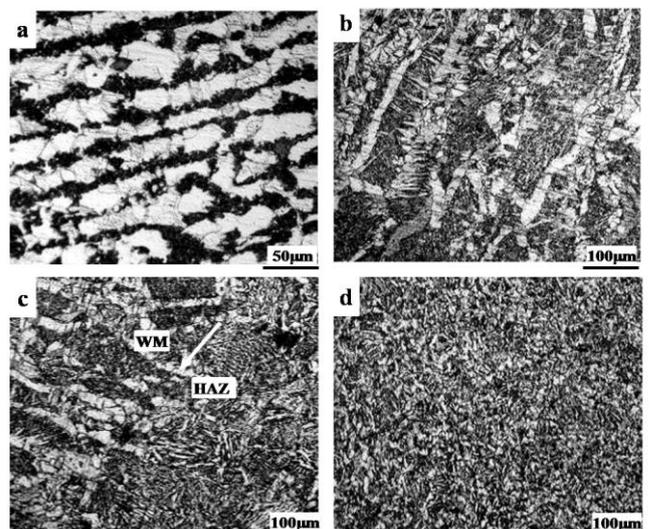
Fig. 5 Microstructures of the weld no. 3: (a) base metal, (b) weld metal, (c) fusion line and (d) fine heat affected zone.

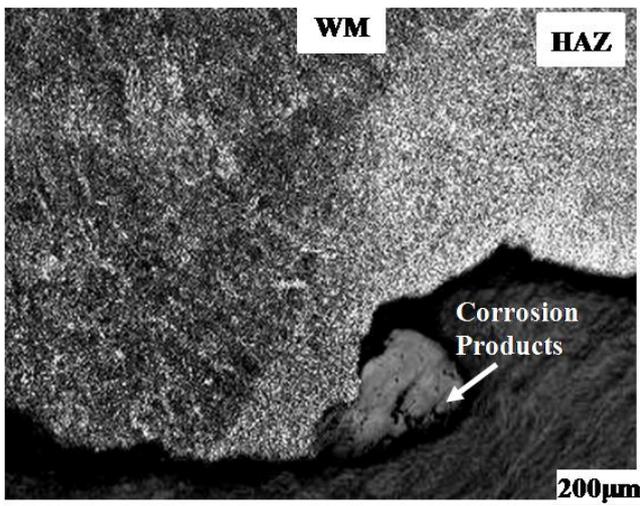
Fig. 6 Microstructures at the root of the weld no. 3 showing corrosion products.

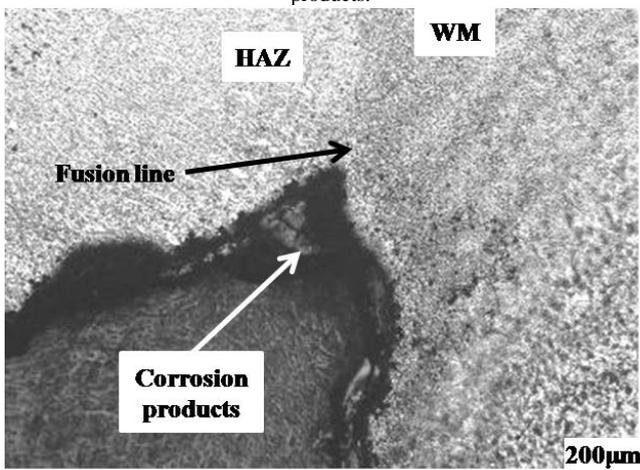
Same Corrosion damage phenomena was also observed at other weld joints as shown in Figs. 7&8, where the corrosion attack also started at HAZ near at the weld, exactly at fusion line. Examination of fracture surface of weld no. 3 at high magnification using SEM showed ductile dimpled fracture (Fig. 9a). Corrosion attack is characterized by deep groove, rounded holes and valleys (Fig. 9 b & c). Energy Dispersive spectroscopy (EDS) was also used to examine the fracture surface. An example of the EDS analysis of the weld no. 3 is shown in Fig.10. The aggressive elements such as Cl and S are quite present at mild concentrations. The XRD analysis of the corrosion products taken from the corroded surface and weld root is shown in Fig. 11. The results showed the presence of Fe₃ O₄, (FeSO₃. 2.5 H₂ O), Fe OO H, Fe S and Fe Cl. Macro Vickers hardness profile was carried out for base metal, HAZ and weld metal for weld no.3 as shown in Fig. 12. The hardness values of WM and HAZ were the highest (250Hv), while those measured for BM were the lowest (160 Hv). The

Fig. 7 Macrostructures at the root of the weld no.1 showing corrosion at fusion line.

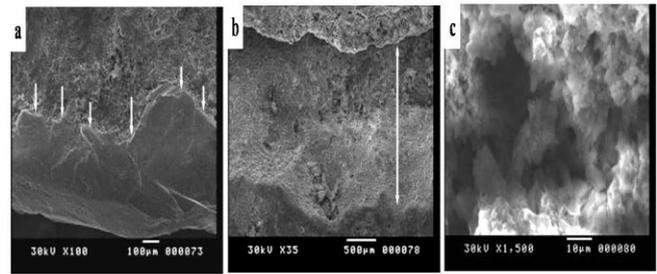
Fig. 8 SEM photographs: (a) fracture surface of the failed weld, (b) corrosion appearance at fusion line of the weld no. 3 and (c) the corroded surface at higher magnification.

Since the investigation of interior surface revealed moderate general corrosion with few shallow pits, the ductile nature of the fractured surface revealed by SEM (Fig. 9 a, b) and corrosion morphology (Fig.10c) of the girth welds indicate that the spool was fractured due to erosion – corrosion mechanism. Erosion – corrosion is the acceleration of metal deterioration due to the relative movement between the fluid and metal surface [9-12]. Velocity strongly influences erosion-corrosion, yet it is not the origin for this failure. Also, the type of flow is not only the main reason that caused this erosion –corrosion failure at girth welds. Actually the presence of protrusions due to the excess penetration of the root weld bead (Figs. 3&4) had made an obstruction that disturbed the laminar flow pattern and created a localized turbulent flow conditions with greater agitation and eddy movement. Metal is removed from the surface as dissolved ions, or forms of solid corrosion products, which are mechanically swept from the metal surface. Many types of corrosive mediums could cause erosion-corrosion. These include gases, aqueous solutions and organic systems. Solids suspensions in liquids are particularly destructive in of erosion-corrosion. This largely accelerates erosion- corrosion leading to failure in a relatively short time [3-8]. In addition, the high hardness values of HAZ and WM are an indication of high heat input which in turn led to the formation of coarse grains near fusion line [3]. This created a heterogeneous structure and localized thermal stresses around fusion line and HAZ, facilitating corrosion attack through this zone following the erosion-corrosion mechanism indicated above [9-12].

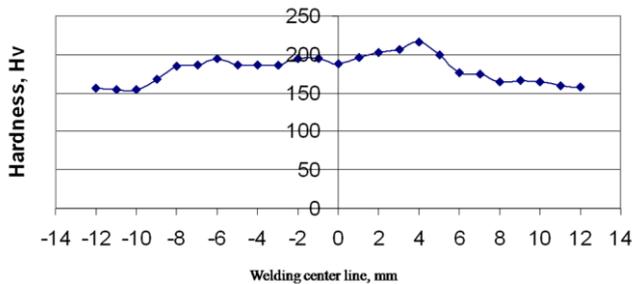
hardness of HAZ is relatively higher than values specified by API 5X1 standard (~ 180 HV). The results of tensile test of the base metal are given in Table 2. These results are in a good agreement with the requirements of API 5XL standard for grade X 52.

Fig. 11 Results of hardness profile of welding no. 3.
