Specific Features of Historical Structures of Buildings and Road Facilities in Bulgaria in 19th and In the Beginning of 20th Century

Doncho Partov, Petar Grekov, Vesselin Kantchev

Abstract— The aim of the study is an analysis of some constructive systems in Bulgarian architecture in 19th century and in the beginning of 20th century. In the historical development of Bulgaria this is the time of changes in all areas of life. The period is connected with the transition from the Middle Ages to the Modern Era and the perception of the changes brought about by the industrial development in Europe. The wooden and steel constructions used in cult and public buildings and facilities have been explored. The use of different types of materials for these structures is related to the functions of the facilities, their social and industrial significance. In the course of the study, the hypothesis of the unity of the construction system and its relation to the terrain is confirmed. The unity of the construction system is considered as a significant problem, because builders during this period follow the local historical tradition and good knowledge of the craft. Following the tradition they wor

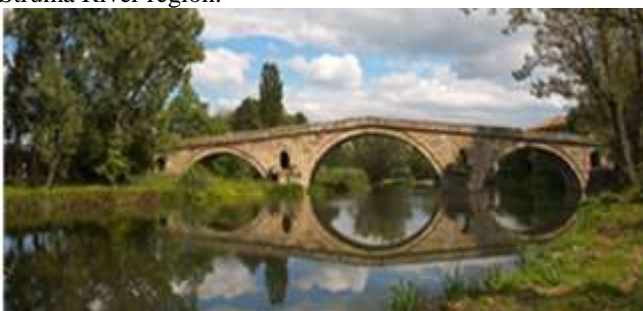
Figure 6: Kadin bridge.

Kadin Bridge is an arch bridge over the Struma River near to Nevestino, Kiustendil region. The bridge was built in 1470 on the order of Vizier Isaac Pasha during the reign of Ottoman sultan Mehmed II. Nowadays the bridge is still in use with a limited load-carrying capacity of 200 kN vehicles[10]. The bridge was proclaimed a monument of culture in 1968. The structure is a close-spandrel deck-arch stone bridge with a total length of 100.00 m and includes three main spans of 14.80 m + 20.00 m + 13.50 m. Additional two spans help to capture the capacity of the spring high level of the river water. They have spans of 4.80 m and 3.00 m. All arches are approximately semicircular shaped and have a total width of 6.00 m. The bridge deck is 5.60 m wide and has symmetrical longitudinal slopes of 10%. The stone parapet is 0.40 m wide and the height varies from 0.40 to 1.00 m. The main piers have dimensions of 5.00x6.00 m. The material used for the bridge construction is high quality granite. The piers are supported by timber piles. The bridge structure survived one of the strongest earthquakes in Bulgaria in 1904 with a magnitude of 7.8 of the Richter scale and epicentre in the Struma River region.

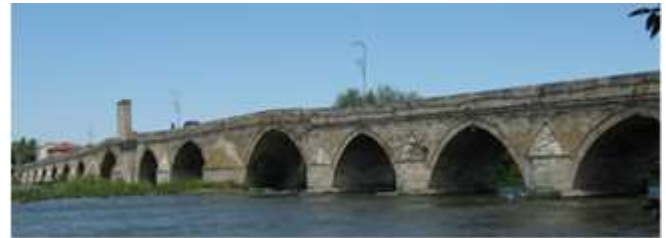
Figure 7: The Old Bridge.

The Old Bridge or Mustafa Pasha Bridge is a stone arch bridge as shown in Figure 7, over the Maritsa River near to Svilengrad (with an old name: Mustafa Pasha). The bridge was built in 1529 on the order of Vizier Mustafa Pasha. The bridge is proclaimed as a monument of culture with an owner the Road Infrastructure Agency. The structure is a close-spandrel deck-arch bridge with a total length of 286.00 m and includes 18 main spans with a widest span of 18.00 m. Additional two spans help to capture the capacity of the spring high level of the river water. The bridge arches are shaped according to the typical Arabian style with tapered crowns of arches. The total width of the bridge is 7.00 m. The deck has a stone parapet 0.33 m wide and the height varies from 0.40 m to 0.80 m. The three middle piers have dimensions of 9.50x6.80 m; the remaining piers have dimensions of 3.50x6.80 m. The piers stone footings are timber pile foundations. The bridge structure survived one of the strongest earthquakes in Bulgaria in 1928 with a magnitude of 7.0 on the Richter scale with epicentre near to Popovica.

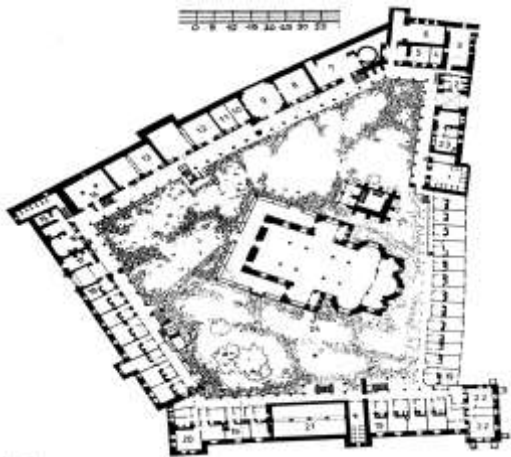
Figure 8: Plan of Rila Monastery.

The Monastery was erected as a closed complex of buildings, surrounding an inner yard in the form of an irregular quadrangle (Figure 8). The outer architecture has the characteristics of a fortress. The walls were built by using stone masonry and have window openings. The width of the walls varies in proportion to their height from 1.6 m at the foundations to 0.8m at the top. The front elevation consists of two main elements - arches and columns. The inside walls have timber structures filled with brick masonry. The floor and roof structures are made of timber. The roof was repaired in the twenties. The Central church is constructed in Byzantium Athos monastery traditions. It is domed basilica. The monastery housing wings have four storey's and contain more than 300 monastic accommodations, 4 chapels and numerous guest-rooms and storerooms. The most interesting of all premises is the large monastery kitchen, called "magernitsa"[11]. It is a massive tower in the form of a pyramid, which passes through all floors and ends up over the

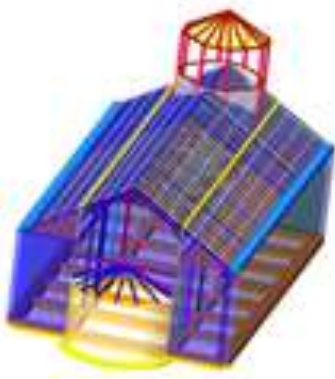
Figure 13: 3D dimensional computational model for structural system

supported on wooden columns. Above this elevation wooden columns continue up to a height of 1,96 m. Above the galleries, columns are united with one purlin, which lies on them in the distances marked in digital axes. Purlin rests on columns by pillow. The slope of the roof (32°) is formed with inclined ribs which lie in the lower end on the stone walls. The rehabilitation of the timber beams supports was performed through the fixation with steel triangle and steel bolts. Anchoring of purlins to the outside wall is recommended to be done using the steel lashes and steel bolts (Figure 12). Strengthening of the damaged structural element (console-pillow and beam-purlin) with steel are performed by steel lashes and steel bolts also. Using the numerical analysis of the timber roof of the church is shown the potentials of a three-dimensional computer modelling and simulation of a building structure. However it is shown: how the science of engineering in particular, and advanced computer modelling including finite element methods, can be used to increase the understanding of a whole structure and also demonstrate how to apply this method to a historical building structure (Figure 13).

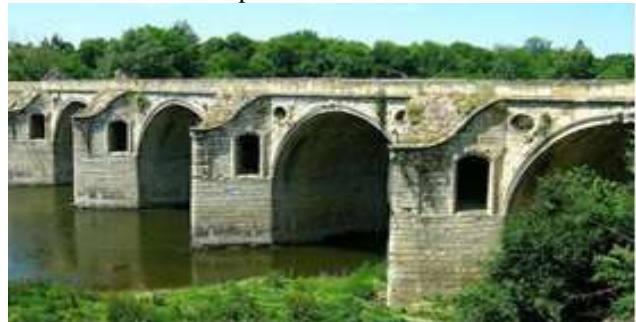
Figure 14: Belenski bridge.

Belenski bridge (Figure 14) is a stone arch bridge placed over the Yantra River near to Byala, Rousse region (Figure 14). The bridge was built in 1867 on the order of Mithad Pasha – statesman of the Danube Province in Ottoman Empire. The bridge builder was the famous local master Kolyo Ficheto. The bridge owner is the Agency “Road Infrastructure” and it was proclaimed a monument of culture in 1980. The structure is a close-spandrel deck-arch bridge with a total length of 276.00 m and includes 14 spans of 12.60 m. All arches rise 4.335 m above the ground. All arches are approximately semicircular shaped and the roadway is 9.00 m wide. The arches are built of two rows of stones with a total height of 0.8 m. The bridge deck has a stone parapet and with dimensions of 0.2x0.9 m. The material used for the bridge construction is a high quality limestone. The arch piers have dimensions of 5.40x9.00 m. Part of the piers footings have a pile foundation consisting of timber piles 6.00 m long with diameter of 0.20 m and distance between them of 0.30 m. The remaining part of the piers footings are bedded on a solid gneiss rock. The bridge structure survived one of the strongest earthquakes in Bulgaria at 1901 with a magnitude of 7.2 on the Richter scale and epicenter near Shabla.

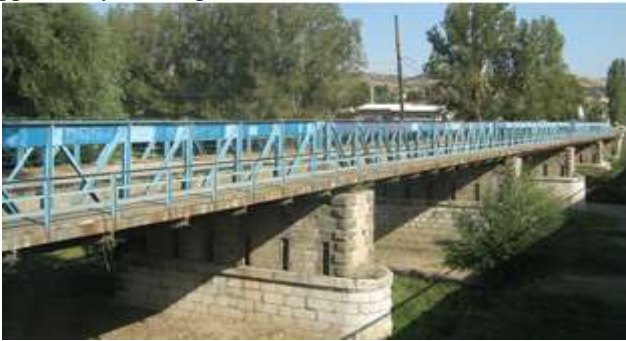
Figure 15: Lom Bridge

The Lom Bridge (Figure 15) is a steel trough-truss structure as shown in Figure 24 over the Lom River near to the Danube riverside town of Lom. The Italian bridge designer and contractor are unknown. The bridge owner is the Municipality of Lom and it was opened to traffic in 1890. Nowadays the bridge is still in use with a limited load-carrying capacity of 200 kN vehicles. The bridge is a 5-span structure with a total length of 117.5 m. Each of the spans consists of two parallel Pratt-type trusses with a distance between them of 5.70 m. The trusses have 10 panels with a total length of 23.50 m and height of 2.20 m. The bridge deck is 8.70 m wide. The truss chords are parallel and have a “T”-shaped cross-sections fabricated by two angle sections, back to back with a steel plate between them. The angle sections are additionally strengthened by steel plates. The truss diagonal members have “I”-shaped cross-section fabricated by four angle sections, back to back with a web of steel plate. The diagonal members are riveted directly to the chord members without gusset plates. All fabricated cross-sections are fastened by a riveting. The floor beams are placed at the lower joints of the trusses and are hot-rolled “I”-sections, 500 mm deep. The bridge deck has five stringers, placed at a distance of 1.14 m. The

stringers also have an “I”-shaped cross-section, 270 mm deep. The concrete deck slab is 120 mm thick. The bridge superstructure has a lower lateral bracing made of hot-rolled angle sections. The truss supports are steel hinged on the one of the pier and steel rollers on the other pier. The bridge abutments and piers are made of stone masonry. The piers are supported by timber piles.

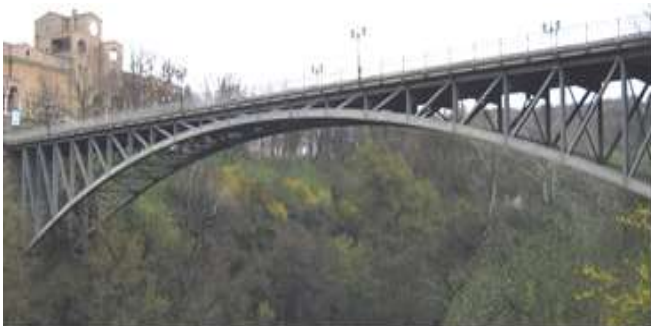
Figure 16: Stambolov bridge.

The Stambolov bridge is an example of quick penetration of steel construction in the road system in the 19th c. It is a steel deck-truss arch structure over the Yantra River at Veliko Tarnovo town (Figure 16). The bridge was designed and built by the Austrian “Waagner-Biro” company and is opened to traffic in 1892. The structure consists of two parallel Pratt-type truss arches with a distance between them of 5.60 m. The truss arches are 8.60 m high at the abutments and 1.20 m at the middle. They have 26 panels with a total length of 81.60 m. The bridge deck is 7.30 m wide. The upper horizontal chord and lower parabolic arch chord of the trusses are “U”-sections, 500 mm deep and fabricated by four angle sections with dimensions of 80x80x10 mm, back to back with a steel plate between them of 20 mm thick.

The outside flanges are additionally strengthened by steel plates with dimensions of 50x240 mm. The vertical and the diagonal members of the trusses have “I”-shaped cross-sections fabricated by four angle sections with dimensions of 120x70x7 mm, back to back with a web of 10 mm thick. The diagonal members are riveted directly to the chord members without gusset plates. The floor beams of the bridge are “I”-shaped, 600 mm high, fabricated by angle sections. The stringers also have an “I”-shaped cross-section. All fabricated cross-sections are fastened by a riveting. Lateral “X” bracings are placed at the upper and the lower chords and at the panel ends.

The bridge is supported on the abutments by steel hinged bearings. The abutment’s foundations are bedded on the solid rocks. The bridge structure survived one of strongest earthquakes in Bulgaria at 1913 with a magnitude of 7.0 on the Richter scale.

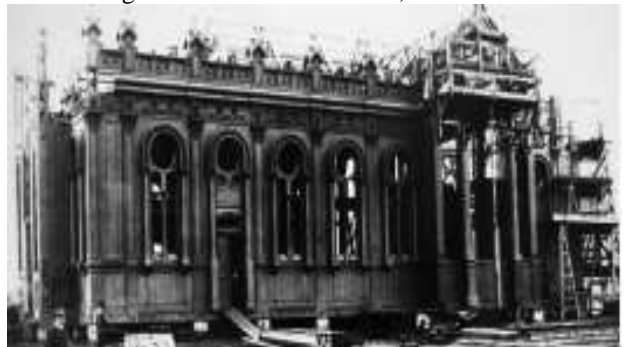
Figure 18: Construction phase of the church—iron structure

The church of St. Stefan in its present form was built between December 1895 and July 1896, funded by the Bulgarian government. The designer was Hovsep Aznavur, an Istanbul architect of Armenian origin. The church itself was constructed by the Rudolf Phillip Waagner Company, and was made with a cast iron façade and steel sheets or rolled sections for the structural elements and ornaments. It was

taken to lighten the weight of the building, which is to be lifted on a landslide terrain which is pre-erected with pendulous piles [12]. According to its plan, the temple is a single-apse three-nave basilica with a short transept and empora, and with an eclectic façade decoration style. Unique roof structural system of church of St. Stefan in Istanbul, together with its architectural design will be explained through its main portal frame systems with precisely designed geometry [13], with circular columns in the mid of the space, truss beams and roof detailing with bars. The constructions are without filler and have steel finishes. [14].
