# Soil Liquefaction Effects on R.C.C. Piles

Manoj Jain, R.S.Ojha

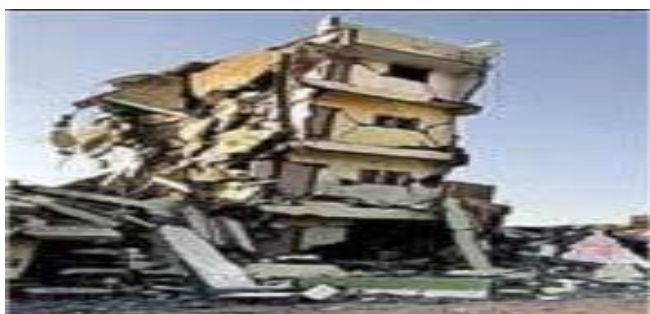
Fig.1 Failure of a residential building during the 2001 Bhuj earthquake (India)

Earthquakes cause damage to engineering structures (Figure 1.) and often result in loss of lives. The recent Indian earthquake at Bhuj on 26th January 2001 is estimated to have cost more than 5 billion U.S. dollars but, more significantly, the death toll was more than 20,000.[1] Forecasting the exact time of an earthquake can at best reduce casualties, which at present appears to be an impossible task. Therefore, structures need to be designed to withstand the impact of an earthquake and prevent collapse, as "it is buildings that kill people, not earthquakes". [2]

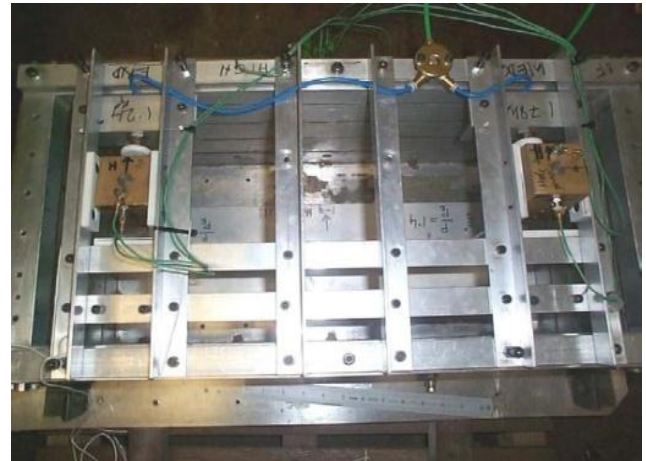
Figure 5 Surface observation after the test

It is quite well known that the most recognised field evidence of soil liquefaction is the presence of sand boils at the ground surface following an earthquake the surface observation of the piles after the tests. It must be noted that the piles that failed had their heads rotated which is quite similar to the visual observations of the piled structures after an earthquake. This demonstrates that centrifuge modelling can reproduce physical mechanisms observed at real earthquakes. It must also be noted that the model piles in the experiments were in
